# VEHICLE INSPECTION REPORT

**KU13KWO**

## Daf LF 55.220

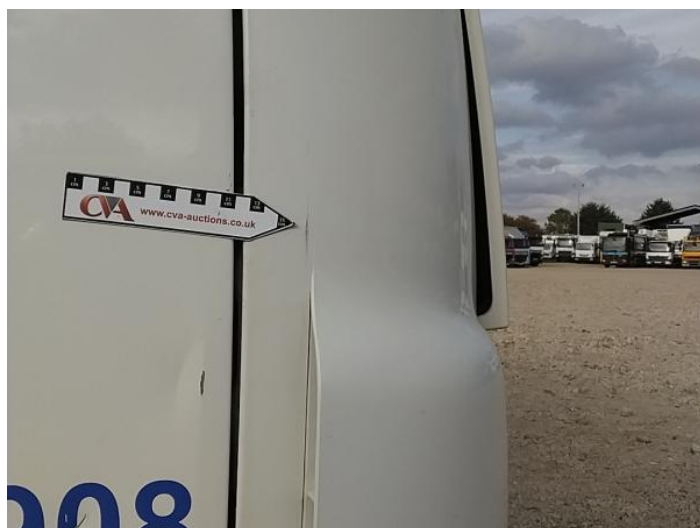
1: Wing osf  
Scratched  
UpTo 25mm Thru Paint

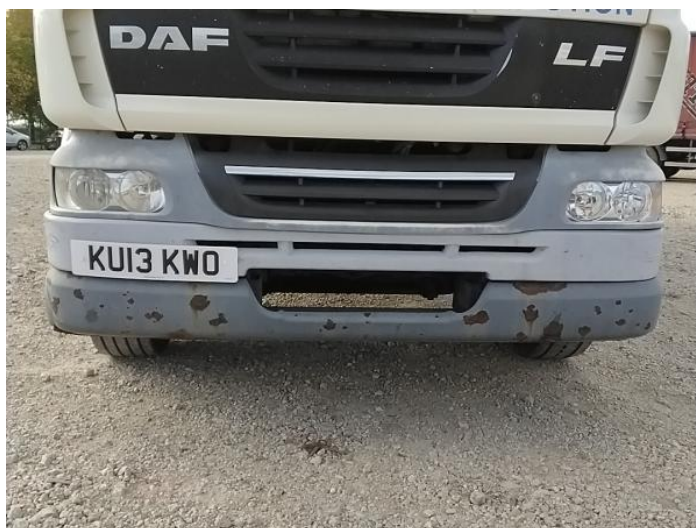
2: Bumper Front  
Rusted  
Over 5mm

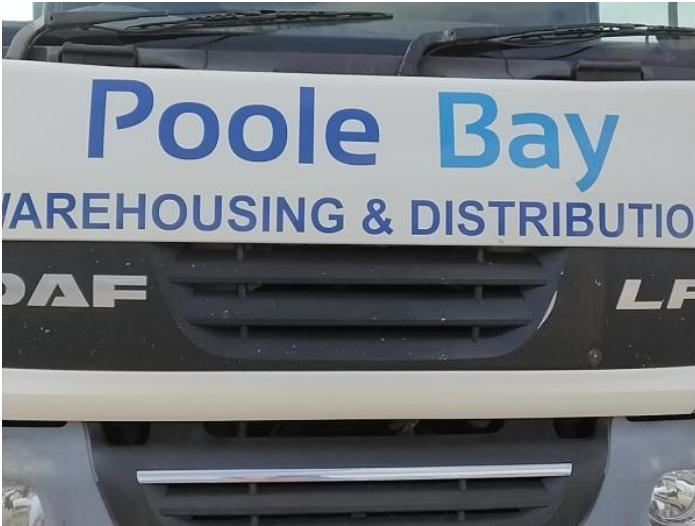
3: Grille Front  
Scratched (Painted)  
UpTo 25mm Thru Paint

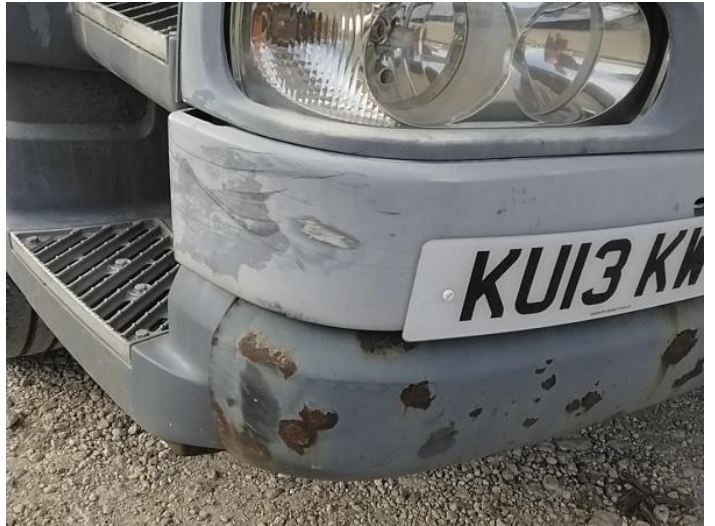
4: Bumper Front Moulding  
Scuffed (Unpainted)  
Over 100mm

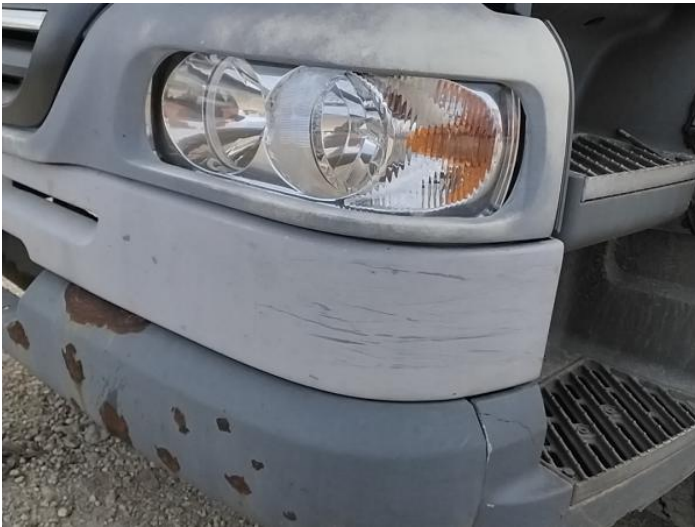
5: Bumper Front Moulding  
Scuffed (Unpainted)  
Over 100mm

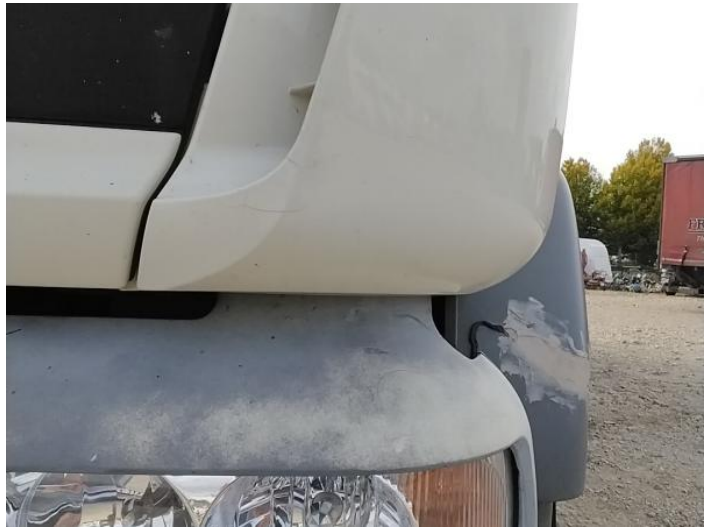
6: Wing nsf  
Cracked  
Replace

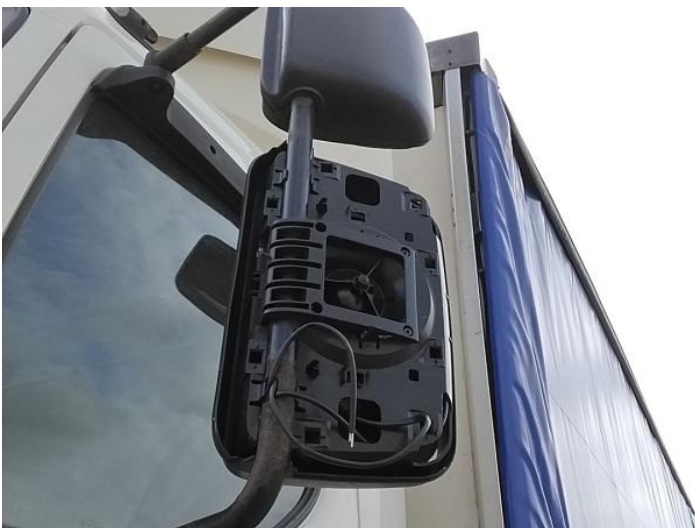
7: Door Mirror Assy nsf  
Missing  
Replace

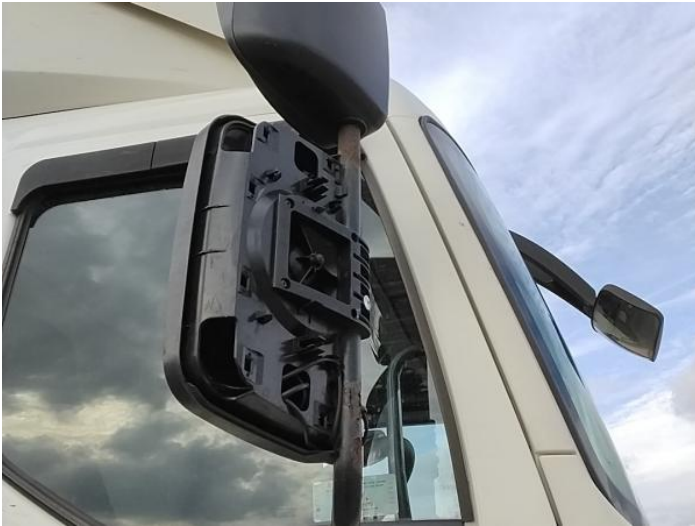
15: Door Mirror Assy osf  
Missing  
Replace

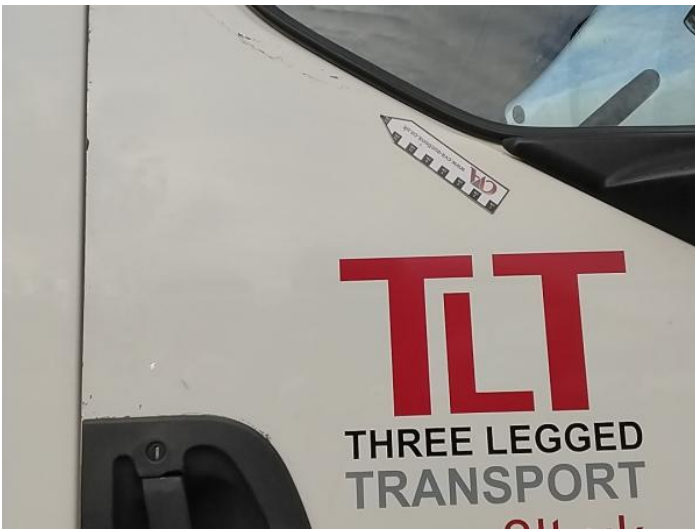
17: Door osf  
Scratched  
UpTo 25mm Thru Paint

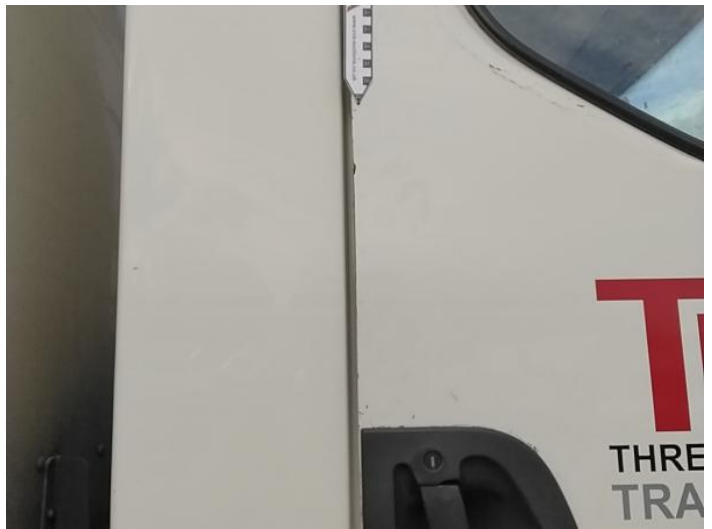
18: Door osf  
Chipped  
Edge Chip

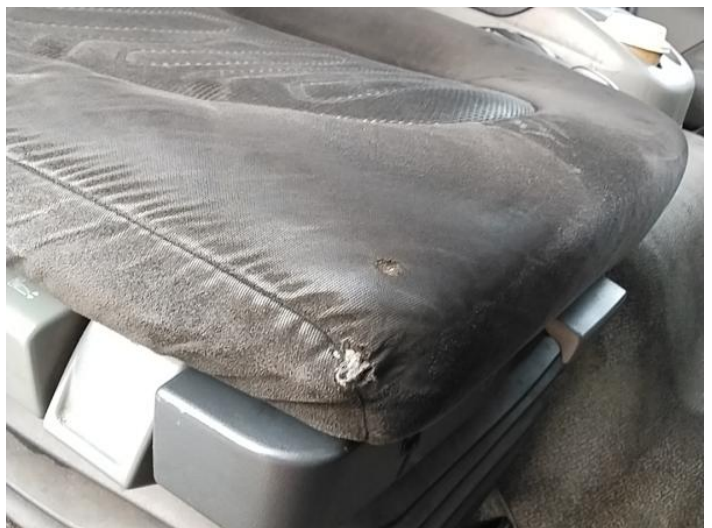
20: Seat Base Cover osf  
Holed  
Over 3mm

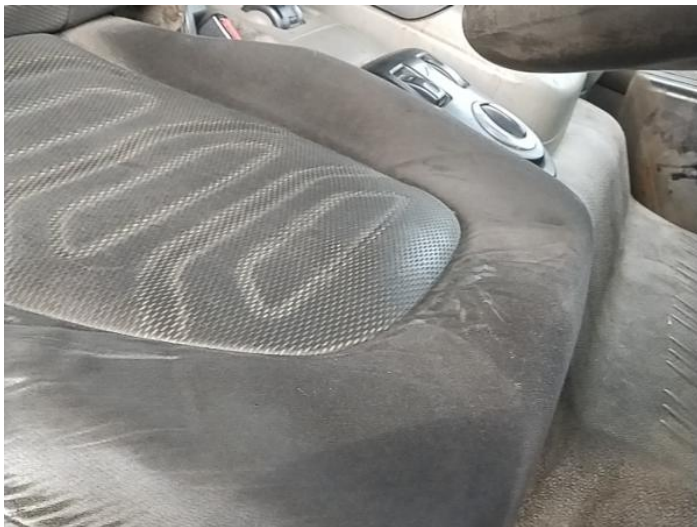
21: Seat Base Cover osf  
Burn  
Over 3mm

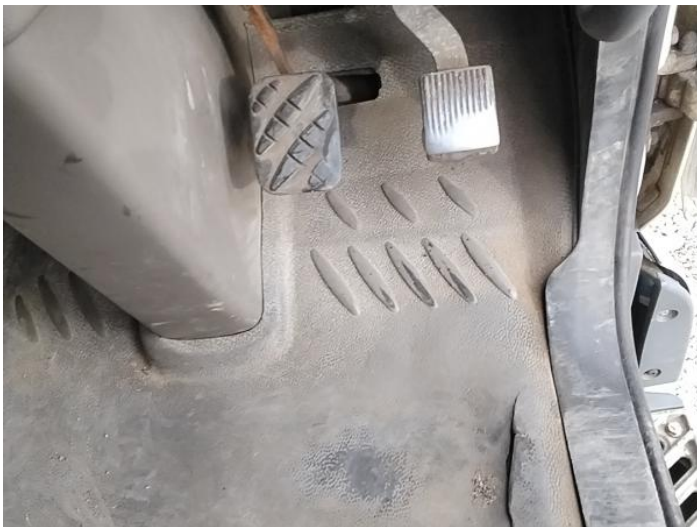
22: Carpets Front  
Torn  
Over 10mm
